Neuroscience Unit

Ventriculoperitoneal Shunt

Patient Information

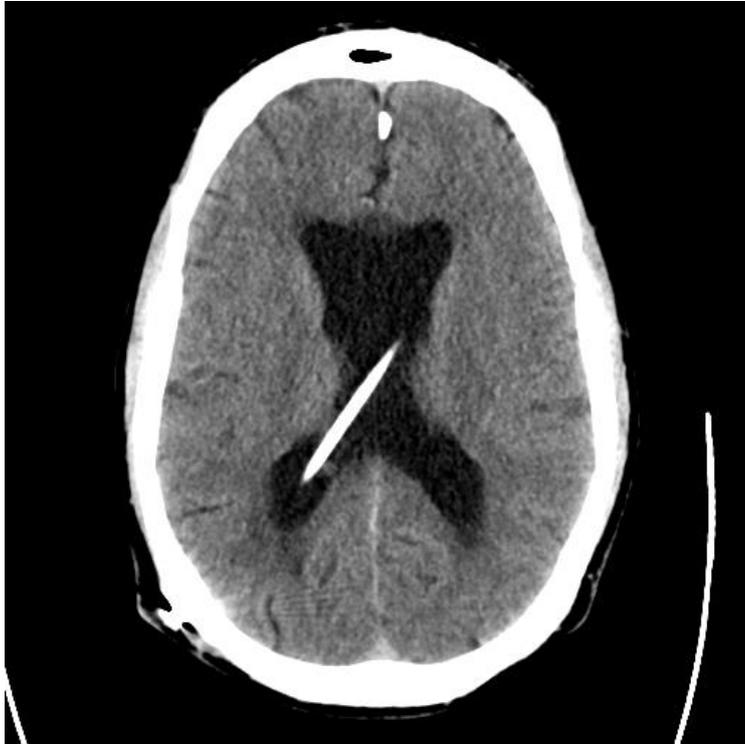
Case courtesy of Dr Henry Knipe, Radiopaedia.org, rID: 39615
<https://radiopaedia.org/licence> From the case
“<https://radiopaedia.org/cases/fractured-ventriculoperitoneal-shunt-with-resultant-hydrocephalus>”

The abdomen is opened with a small incision. The shunt is then assembled and passed through the metal tube, and connected to the ventricular catheter and the bottom end is inserted into the abdominal cavity. The incisions are then closed.
